# Case study

## *Monitoring solution for waste water treatment plants*

## Project: Repair of waste water treatment plant

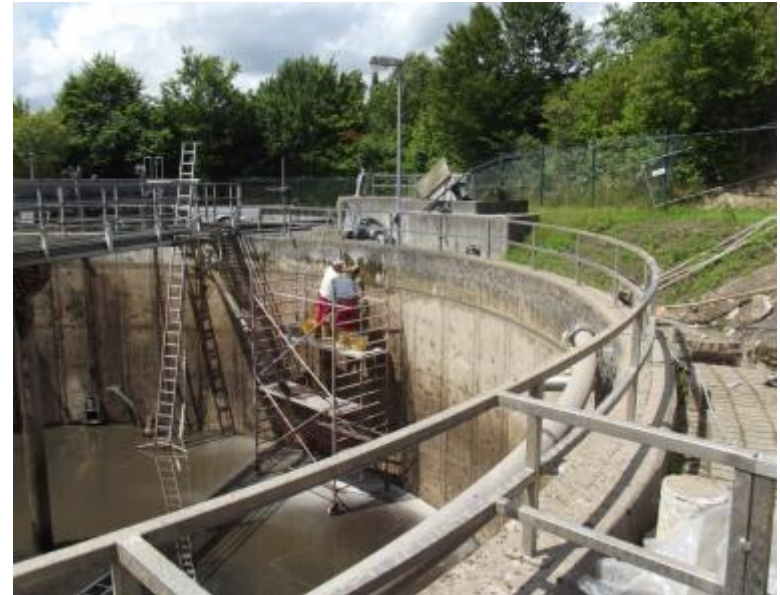
As a result of operational retrofitting work, core holes were created for building inspection. At the core, sample tests were made with regard to compressive strength and carbonation.

The aim of using the corrosion sensors was monitoring the carbonation in the water exchange area of the clarifier.

After the cores were taken and the depth of the carbonation was known, the corrosion sensors were installed in the open core holes using a special mortar. Then a wireless, energy and non-destructive monitoring of corrosion of the structure at critical points could be performed. The operator thus has a significant information advantage and can act purposefully and early.
